Brief report on archaeological survey at the western causeway of Angkor Wat: 2015-2017

Sophia Asia Center for Research and Human Development and
APSARA Authority

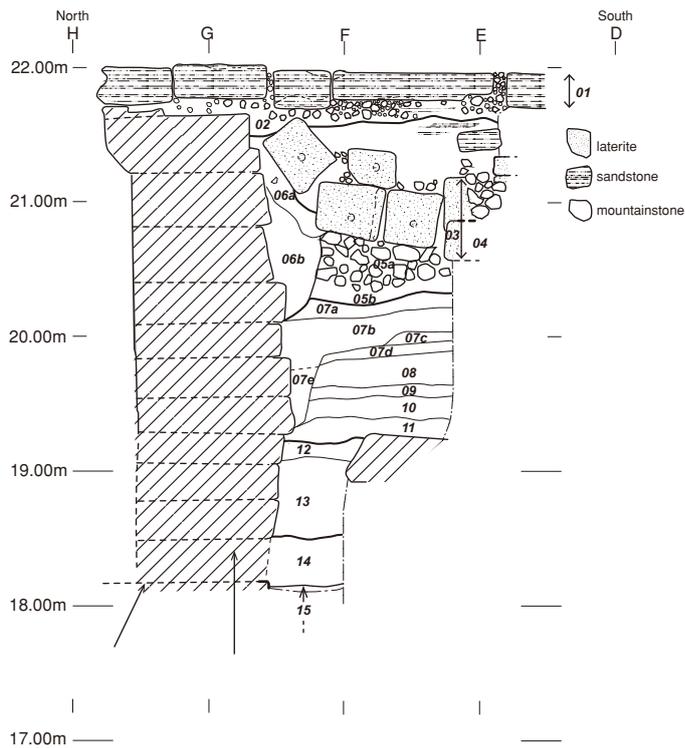
Fig. 3-1 East section, grid line: 81m, test trench 01 May 2017

- 01 : Sandstone floor
- 02 : 5YR5/6 bright reddish brown: silty fine sand, mountain stone chips (dia.4cm-), some small sandstone chips
- 03 : 5YR4/6 reddish brown: silty fine sand, big (dia.13cm-) and small sandstone chips, some pieces of laterite chips
- 04 : laterite blocks
- 05a : 5YR5/8 bright reddish brown: silty fine sand, big mountain stone chips (dia.13cm-), some laterite chips
- 05b : 5YR6/8 orange-7/4 dull orange: silty fine sand, laterite gravel, manganese
- 06a : 5YR5/6 bright reddish brown: silty fine sand, some laterite chips
- 06b : 5YR4/6 reddish brown: sandy fine sand, some laterite chips, some small sandstone chips, a few mountain stones
- 07a : 7.5YR6/8 orange-5/8 bright brown: sandy clay, a lot of laterite chips and fear pieces of sandstone chips
- 07b : 7.5YR6/8 orange-7/1 light brown gray: sandy clay, some laterite chips, a few pieces of sandstone chips

- 07c : 5YR5/8 bright reddish brown: silty fine sand, little pieces of laterite chips
- 07d : 7.5YR6/8 orange-5/8 bright brown: sandy clay, a lot of laterite chips
- 07e : 7.5YR5/8 bright brown: silty fine to medium sand, sandy clay
- 08 : 10YR5/8 yellow orange: clay block, silty fine to medium sand
- 09 : 10YR5/8 Yellowish brown: clay block, fine sand to medium sand
- 10 : 7.5YR5/6 bright brown: clay block, silty fine to medium sand
- 11 : 7.5YR5/6 bright brown: fine to medium sandy clay
- 12 : 5YR4/8 reddish brown: fine to medium sandy clay, laterite chips
- 13 : 7.5YR 5/6 bright brown: fine to medium sandy clay, silty medium sand
- 14 : 7.5YR 5/8 bright brown: clay block, silty fine sand
- 15 : 5YR 5/6 bright reddish brown: fine sand

Laterite wall is well conserved which is supposed to be keeping position constructed, on the other hand both sections of east and west, big blocks of laterite subsiding deeper to the south were observed. These blocks of laterite were originally covered surface of soil at the same level with the top of laterite wall, then blocks of sandstone were set over laterites. The story once happened sandy soil of layer no.05 flowed out gradually, then only mountain stones remains there, finally laterite stones were subsided, however laterite wall itself has not been damaged at all.

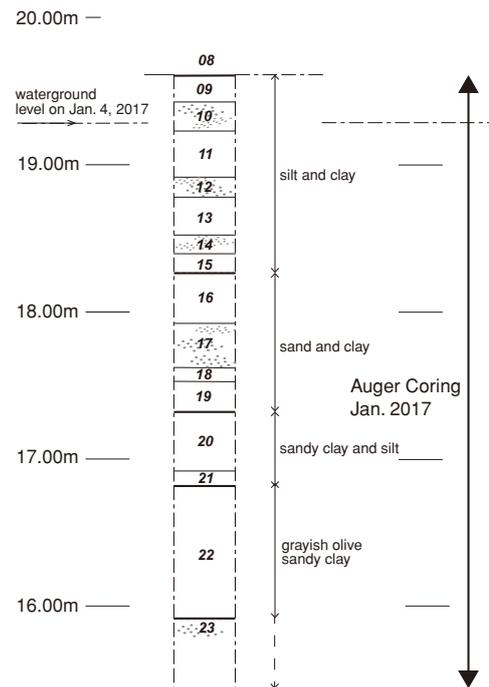
Fig. 3-2 Auger Coring, East section, grid line: 81m, test trench 01 Jan. 2017

In the first survey of the trench 01, it was excavated to the depth of 225cm from surface of sandstone-floor, it means 19.500m (sea level, SL). It corresponds with the middle of 6th laterite wall from top (Fig. 3-1). We observed inner condition of the deposited soil and laterite wall. The soil under 19.500 m (SL) was investigated by hand auger coring, because the groundwater level at the time obstructed us to continue a trench survey (Fig. 3-2). The report was submitted to twenty-seventy Technical Session of ICC-Angkor, January 24, 2017. The committee evaluated the result and observation of our first campaign, then made recommendation to excavate again for observation digging down to the basement of the laterite walls. Due to comply with the recommendation, APSARA and Sophia decided to excavate again as second campaign in May 2017.

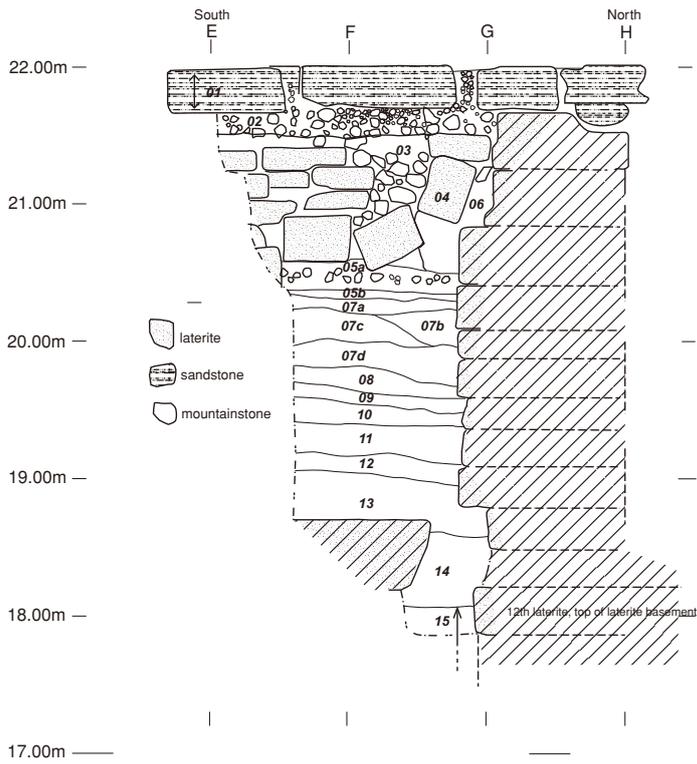
Fig. 4 West section, test trench 01 May 2017

- 08 : 7.5YR5/8 bright brown: fine to medium sandy clay, silty fine to medium sand
- 09 : 10YR5/6 Yellowish brown: clay block, silty fine to medium sand
- 10 : 7.5YR5/6 bright brown: fine to medium sandy clay
- 11 : 7.5YR5/6 bright brown: fine to medium sandy clay
- 12 : 7.5YR5/6 bright brown: silty medium sand, medium sandy clay, clay block
- 13 : 7.5YR 5/6 bright brown: silty fine to medium sand, fine sandy clay

- 14 : 7.5YR 5/8 bright brown: silty fine sand, clay to silt block
- 15 : 5YR 5/6 bright reddish brown: fine sand

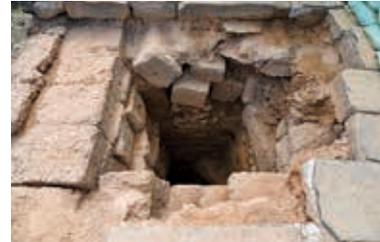
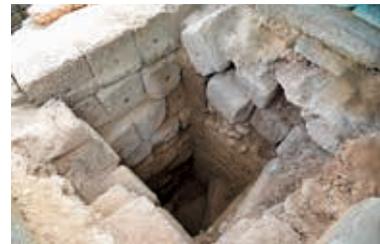
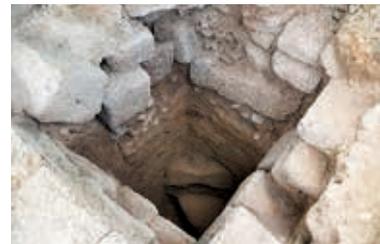
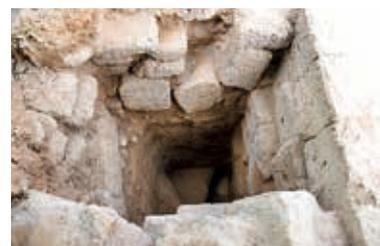
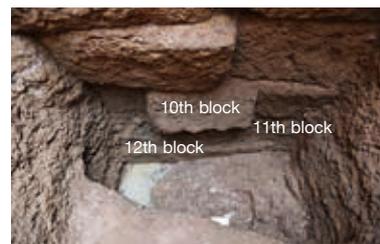
Laterite wall shows 11 blocks piled up, and as a basement 6 more laterite blocks were installed which were observed from moat-side in December 2015. Blocks of laterite wall Through excavation, 12th laterite, top of the basement, was installed in vertical direction with 11th laterite, and under 12th laterite cannot be touched in this campaign.

By measuring cross section of laterite wall at the grid 80m, it doesn't show inclination, and each block is well preserved except 11th laterite. Internal surface of 11th laterite was so weak that it was difficult to identify outline of block.

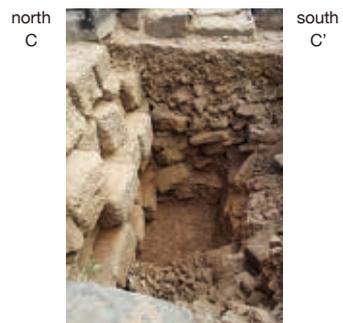
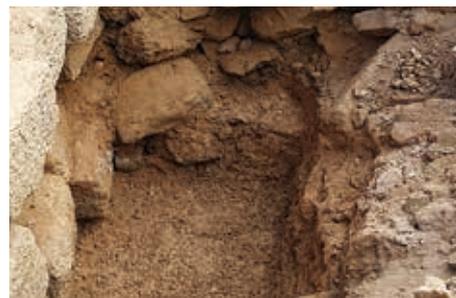
Ph. 13 East section, test trench 02

At the grid 36 area, it also shows a trace of past restoration works. Under sandstone floor (01), a lot of small size of stones: mountain-stones, sandstone chips, and laterite chips were observed in a layer (02), then in deeper position a huge amount of sandstones with carving such as a pilaster, a pediment, a part of building were found (03). These stones indicate to be buried as an internal soil for restoration. Layer 03 is therefore lacking stability, and easy to slide down.

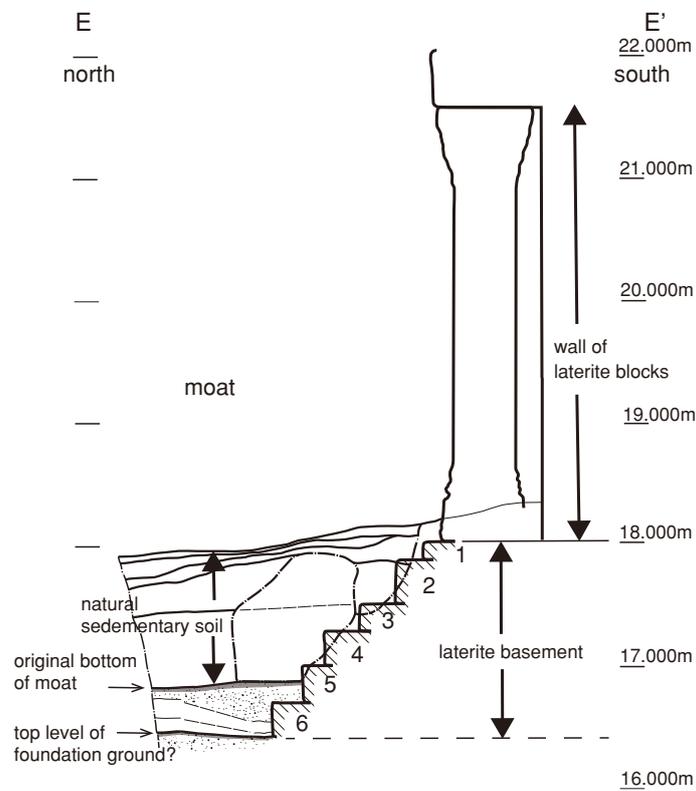
Fig. 8 East section, test trench 2015 December

In December 2015, the mission investigated at the moat side of the western causeway, Angkor Wat. 6 steps of laterite basement were observed, and it cleared that original bottom was hard and packed small laterite chips thickly to its maximum. The condition of basement stones of laterite in lower part: 5th and 6th basement, were conserved in good.

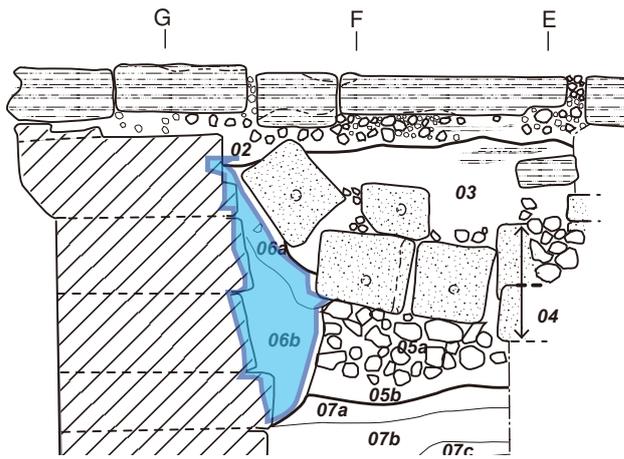
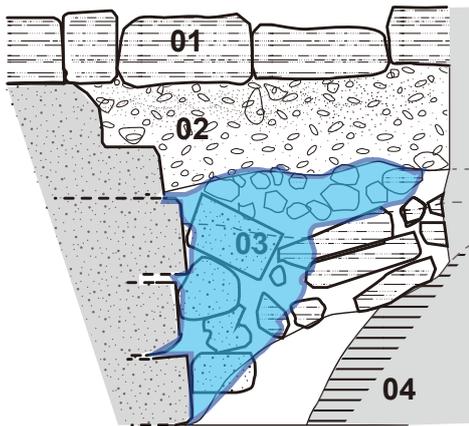
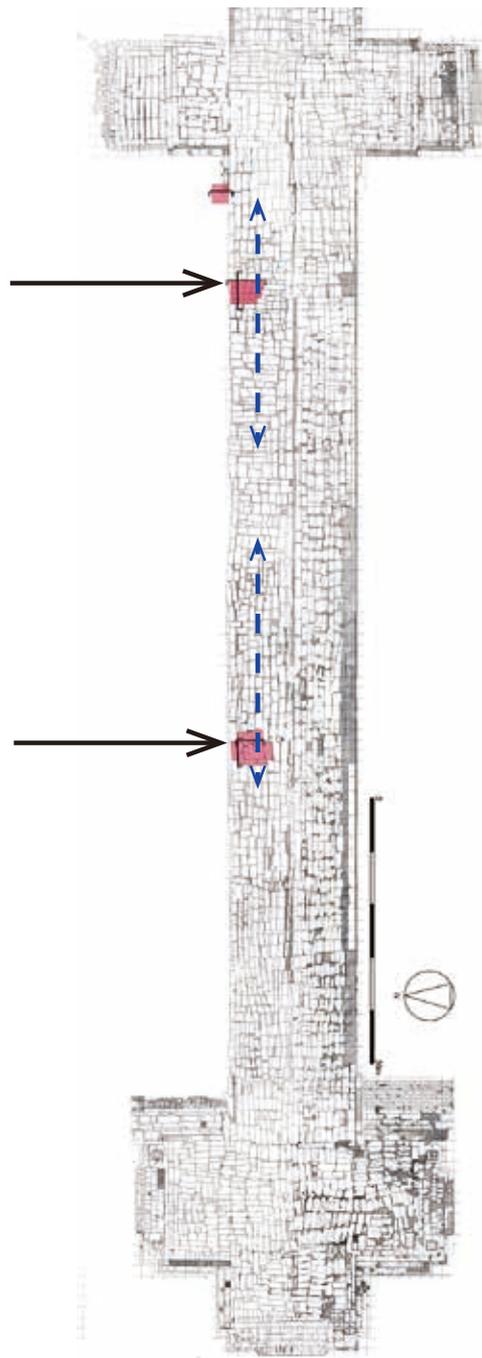
Fig. 9 water, soil, and rubbish flow in an east-west direction inside of western causeway - hypothetical model

Some parts of layers, layer 06a and 06b in trench 01, and layer 03 in trench 02, have cracks and include rubbish such as plastics. It seems they are flowing in an east-west direction inside of causeway (Fig. 9). This observation is particularly worth noting to establish a restoration plan.

Investigation by test trench can clear small range of facts, and additionally the condition is very severe for digging down ground. Research team wants a groundwater level to be down more, to conduct an effective investigation and restoration works.
