THE RESTORATION OF CANDI BOROBUDUR

(1973 – 1983)

Candi Borobudur restoration project

1973 – 1983

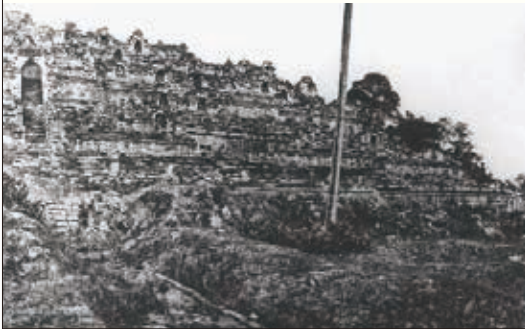
Candi Borobudur condition before 1907

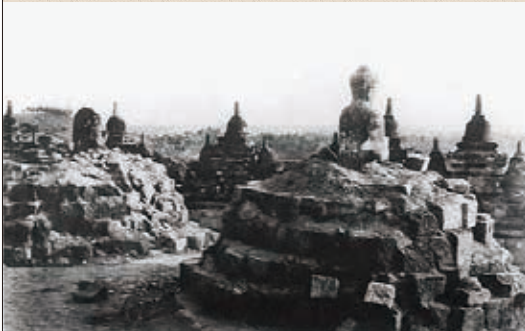
stupa condition before restoration
Theodore Van Erp
1907-1911

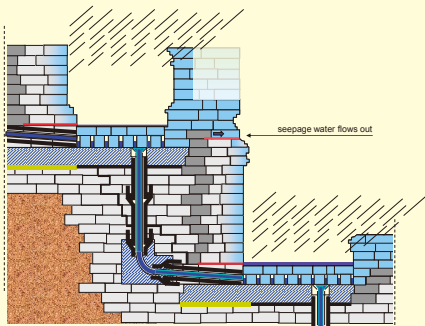
Drainage system with good condition

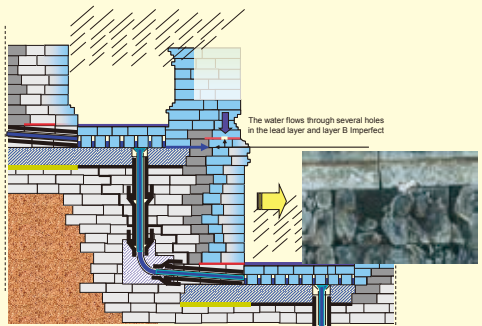
seepage water flows out

Drainage system function is not perfect

The water flows through several holes in the lead layer and layer B imperfect

Repair by dismantling, water seepage balustrade on it and re-use superimposed Araldite tar

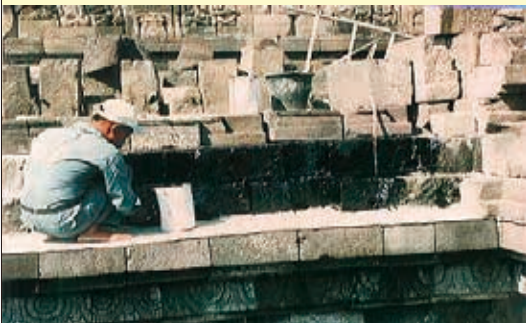
The process of salt deposits

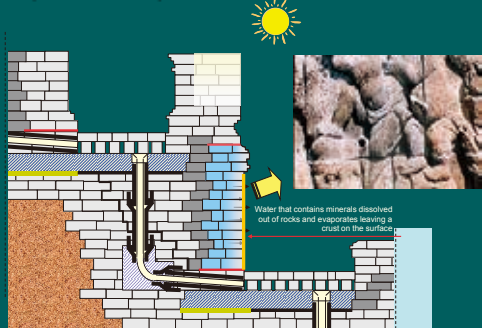
Water that contains minerals dissolved out of rocks and evaporates leaving a crust on the surface
