THE RESTORATION OF CANDI BOROBUDUR

(1973 – 1983)

Candi Borobudur restoration project

1973 – 1983

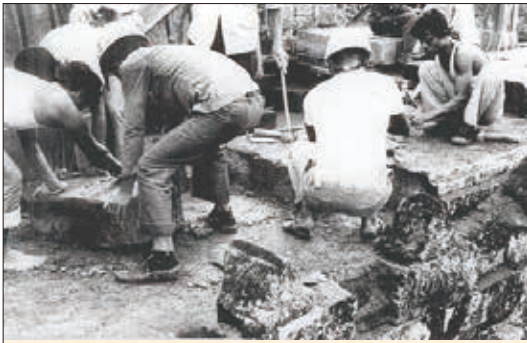
Dismantling of stone blocks

The outer stones were then carefully loosened from their position and placed in the pallet. Removable scaffolding was used to assist in the work and where the stone was too heavy for two men to lift, a scaffold crane was available at each work point.
