THE RESTORATION OF CANDI BOROBUDUR

(1973 – 1983)

Candi Borobudur restoration project

1973 – 1983

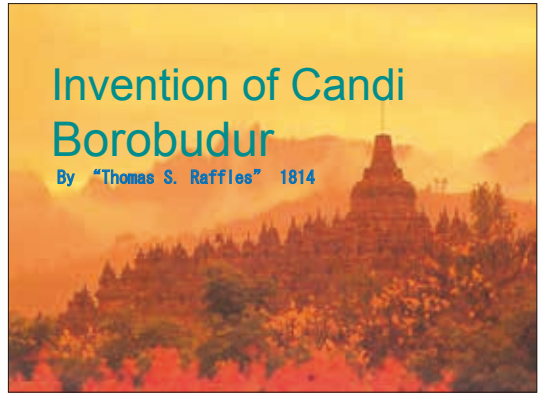
Candi Borobudur condition before 1907

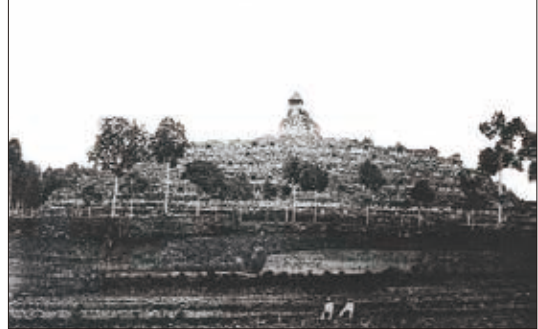
stupa condition before restoration
Theodore Van Erp
1907-1911

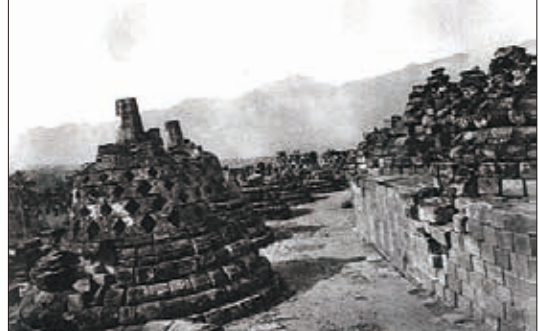
Stupa and terrace of Candi Borobudur before 1854

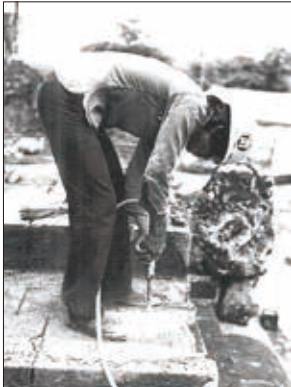
Numbering and coding on stone block before dismantling

The first step in dismantling was marking of stones. In principle no outer stone was to be removed before its pallet and area number had indicated on top surface. The exceptions to this rule were of cause stones whose top surface would be visible and so could not be marked; in these cases the only option was for the markings to be placed on the underside.

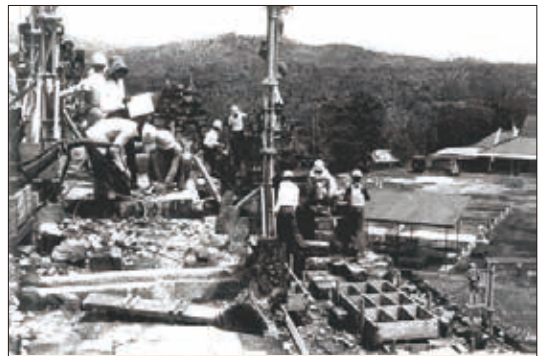
Dismantling of gallery floors are cemented with mortar

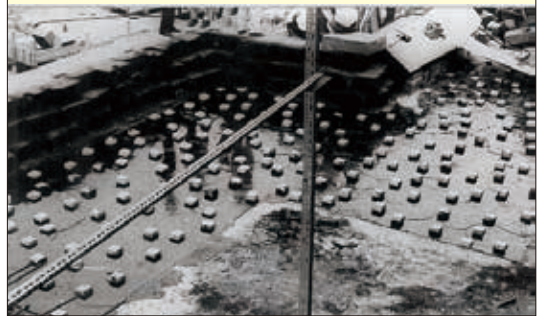
Beginning of reconstruction

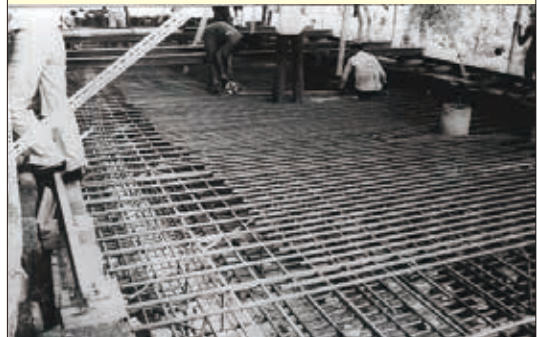
Activity for reinforcement

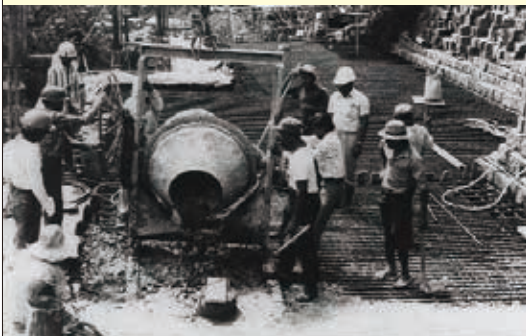
Construction of concrete and drainage pipes

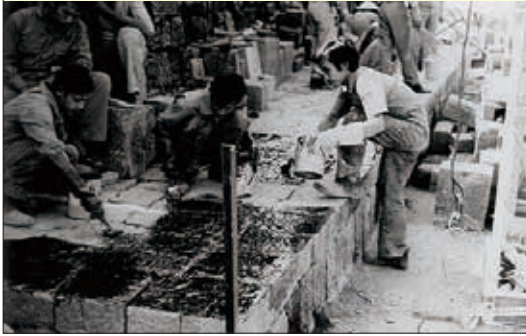
Concrete pipe construction

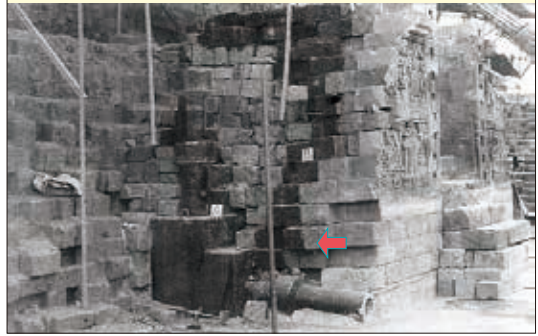
Construction lead coating

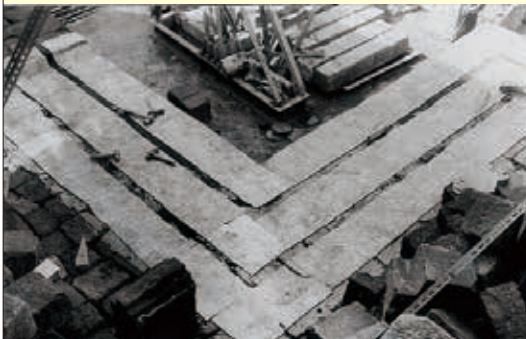
Construction of drainage system

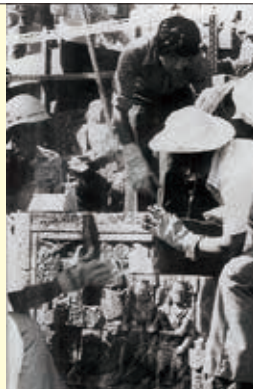
Reassembling inner stone, layer B, and outer stone

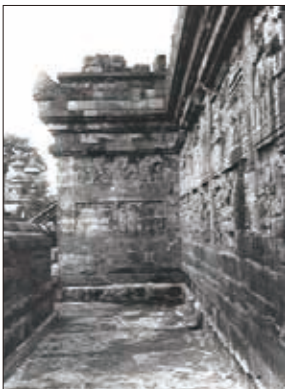
Reassembled wall stone and balustrade

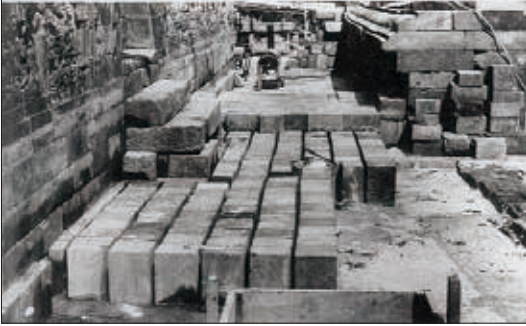
Installation of new floor for gallery

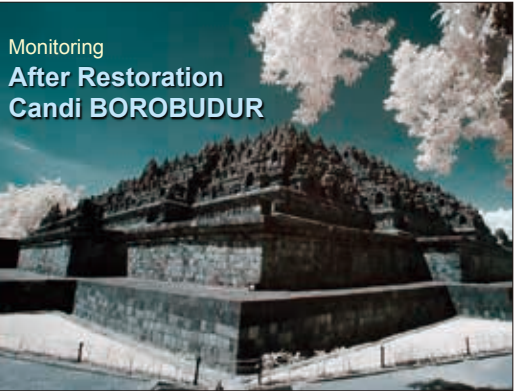
Monitoring After Restoration Candi BOROBUDUR

Drainage system with good condition

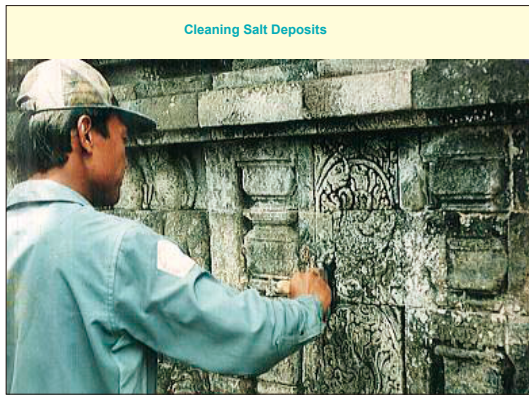
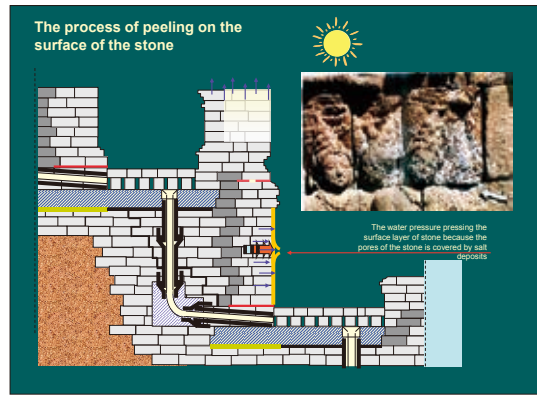
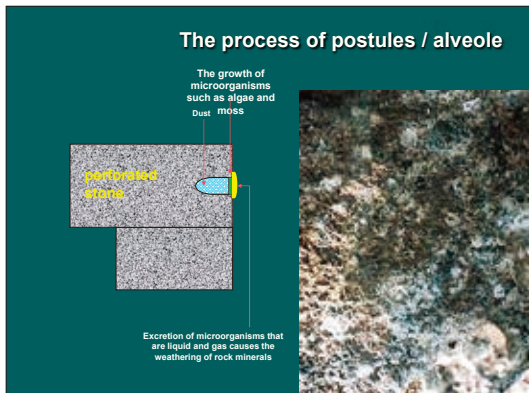
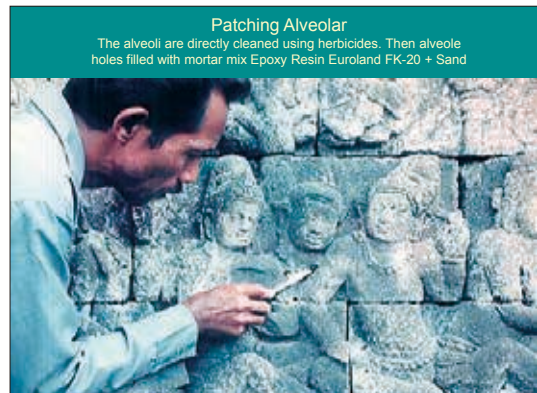
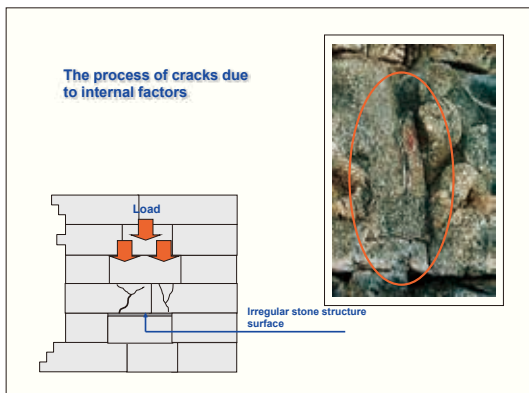
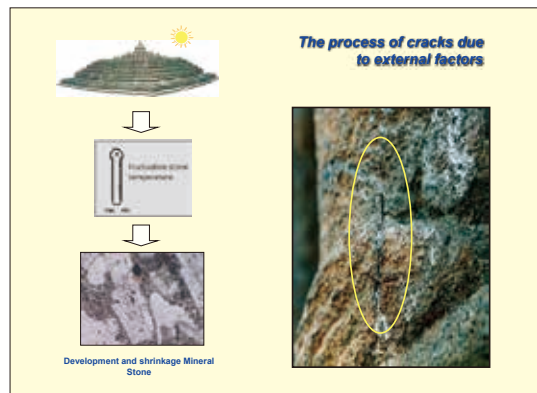
Water that contains minerals dissolved out of rocks and evaporates leaving a crust on the surface
